# Manhole Inspection Summary

Manhole # S2100\_014MH

Insp Date: **7/10/07 8:57 AM**

**Location** Address: **2200 OREM-RUSKIN**

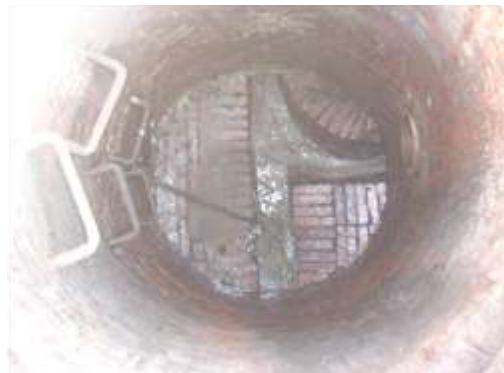
Top View

DEBRIS ON BENCH

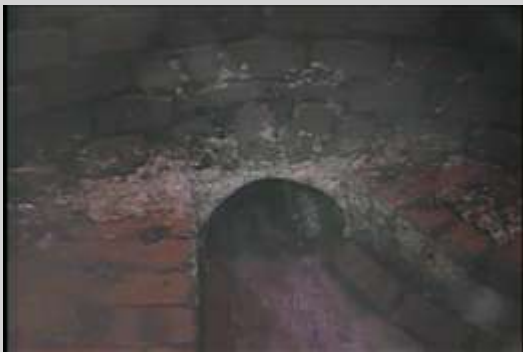
12 O'Clock Outflow

8 in. Circular Gravity Sewer  
Pipe Out @ 12 O'Clock

Pipe Height: **8.4** (in.) Rod and Bar (Angled)  
Pipe Material: **Clay** ☐ Pipe Lined  
Invert Depth: **11.52** (ft.) Flow Characteristics: **Slow**  
Deposits: ☒ None ☐ Mud ☐ ~~Gravy~~ ☐ Debris ☐ Grease  
Silt Depth: (in.) Deposits Extent:  
Infiltration: **None** Pipe Seal Cond: **Sound**
